# Manhole Inspection Summary

Manhole # S31EE2007MH

Insp Date: **11/30/06 11:15 AM**

**Location** Address: **5702 SAINT ALBANS WAY**

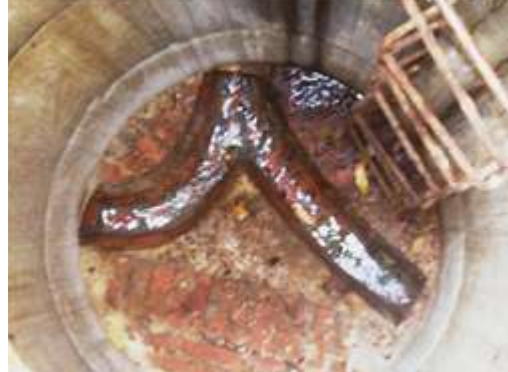
Top View

Bench debris.

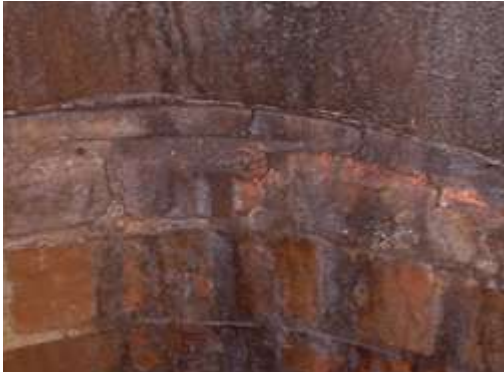
Defect

Frame leaks. Adjustment deterioration and infiltration.

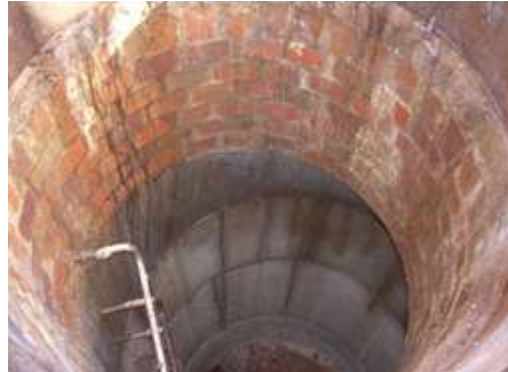
Defect

Adjustment deterioration and infiltration. Corbel infiltration

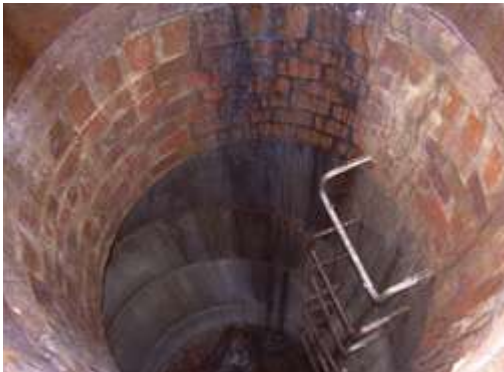
Defect

Adjustment deterioration and infiltration. Corbel infiltration - other side.

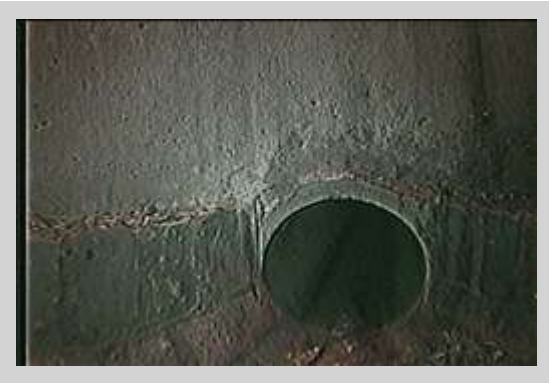
Pipe Out @ 12 O'Clock

Infiltration: **Evidence** Pipe Seal Cond: **Unknown**

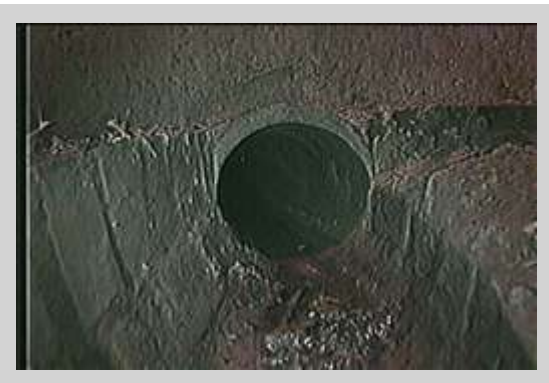
Pipe In @ 4 O'Clock

Infiltration: **Evidence** Pipe Seal Cond: **Cracked**

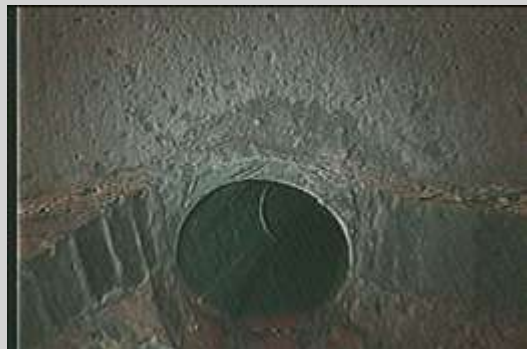
Pipe In @ 9 O'Clock

Infiltration: **Evidence**
